PanelWorld

EVOLVEMENT OF CERAMIC HEAT EXCHANGE MEDIA IN AN RTO FOR THE OSB INDUSTRY

New chemical resistant materials
continue to undergo testing.

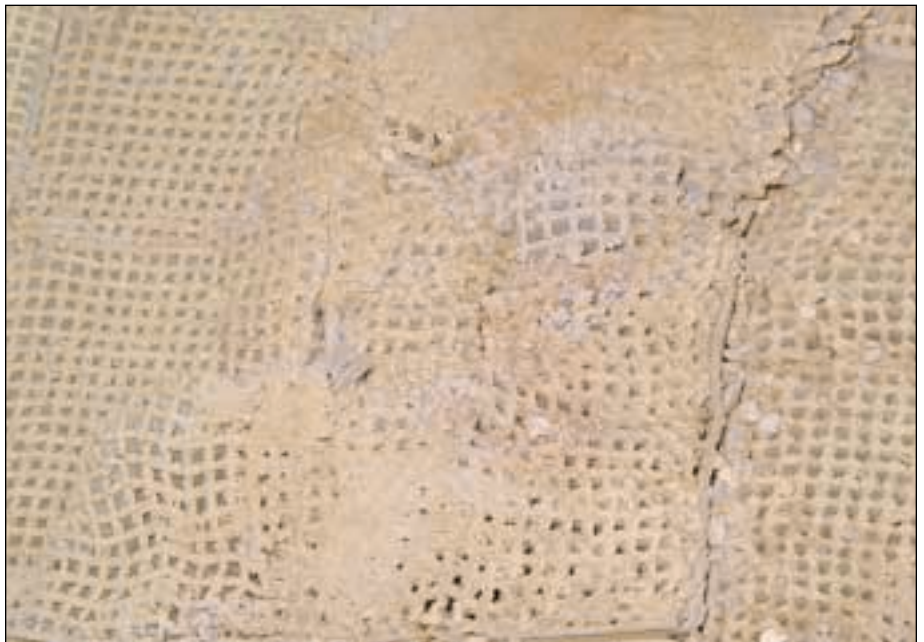
Figure 2: severely restricted airflow

At the same time the cordierite in the South unit was exposed to the same gas stream as the HT in the North unit. The chemical attack from Na_2O and K_2O affected the cordierite in a different manner. The melting temperature of the blocks was reduced thus closing the cells restricting air-flow severely (Figure 2).

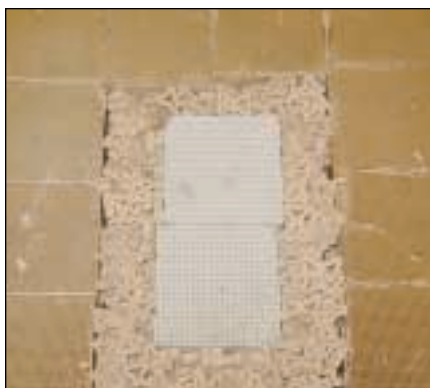
With the problems experienced with both types of ceramic and the inability to use random packings, a new monolith was developed and tested in the actual bed of the North unit called HTH (a second generation alumina mullite monolith with a similar formulation to the HT) (Figure 3).

The two test blocks were returned to the lab for analysis on thermal shock resistance and alkali chemical attack resistance. The tests revealed that the HTH was an improvement over the standard HT material but has positive and negative findings. One positive effect was that more of the SiO_2 was chemically bonded in the block thus reducing the amount of chemical attack that caused chipping. However, a side effect of chemically bonding free SiO_2 was total porosity increased. The pores are fewer but larger in size. Few pores allow less intrusion sites for chemical attack, which is positive, but the larger size allows more Na_2O and K_2O to collect thus increasing the chemical attack. Thermal shock resistance was not changed from the HT material.

Figure 3: HTH monolith

it became necessary to replace the cordierite in the South unit with a material that could better withstand the chemical attack caused by Na_2O and K_2O and other earth contaminants. With the early promising test results of the HTH from the actual test blocks from the North unit, a decision was made to remove the top two layers of cordierite monolith and replace with the HTH 25 x 25 cell monolith.

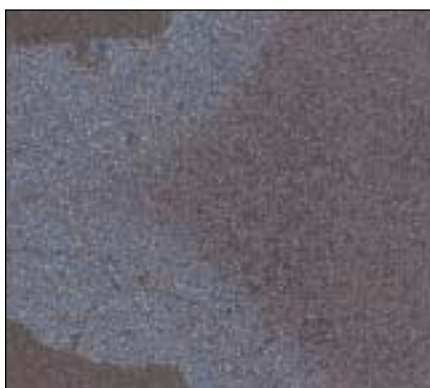
Figure 5: same cross section as above

Figure 5 identifies the same cross section of the same block. The light blue area on the outside of the cell walls shows the distribution of Na (sodium) and K (potas-

sium) in the cross section of honeycomb material "HTH" (light: alkali rich areas). The center dark blue area is virtually unaffected by alkali attack. An effort continued to improve the alkali resistance of the HTH. However the material has reached its potential and an entirely new compound was needed.

original test blocks. However, the block did perform significantly better in the unit over the standard HT monolith. A factor that may have played a role in the increased performance on the HTH was that the monolith installed was a 25-cell material that has larger cell openings and thicker walls. Any chips that were formed in the unit did not completely block the larger cell openings. Also the thicker walls of the block may have slowed the rate of chemical attack (Figure 5).

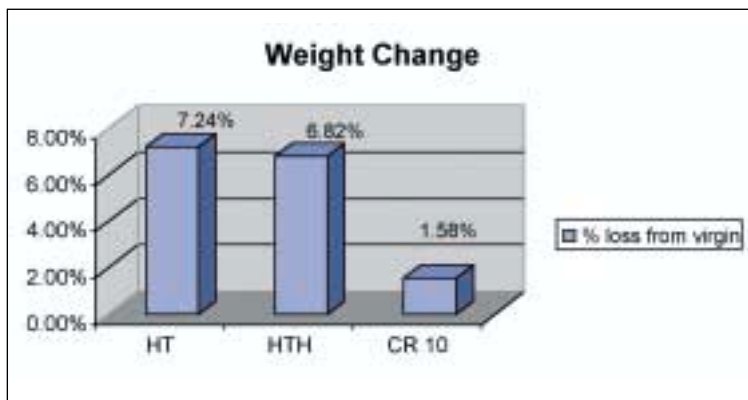
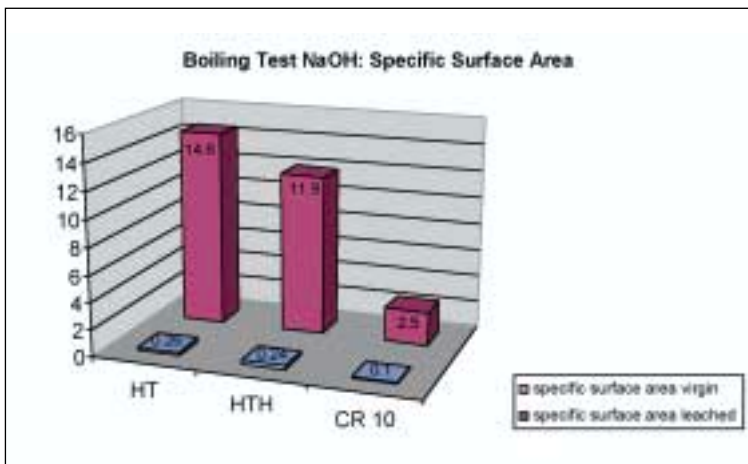
The table identifies that the change in weight from the (virgin) untested material versus the tested material was highest among the HT and HTH series: The most material was leached from the HT (-7.24%) whereas the CR10 had the least (-1.58%). In addition, the surface area of the HT increases many times more than the CR10 (see graphs at right).

Leaching test in NaOH (25%)

testing method: honeycomb specimen
Concentration NaOH: 25%
boiling and stirring 5 hours

measurements: weight loss
specific surface area by N₂-adsorption

CR10 showed a significant increase in alkali resistance and thermal shock in laboratory tests. Cracking resistance is comparable with our NT material that is significantly higher than the HT or HTH materials. As discussed earlier, the HTH did see mixed results in lab testing but a significant increase in performance in the actual RTO. With the improvement in the laboratory tests of the CR10 over the HTH, the expected increase of the CR10 in actual RTO applications is expected to be considerable.
